Re: Mathews County/384 Old Ferry Road
TSG No. VA22105.FOR

With your authorization, we performed a limited forensic structural review of the one (1) story, approximately 1,260 square foot, commercial building located at 384 Old Ferry Road within Mathews County, Virginia. The purpose of our review was to determine if the as-built construction of the raised foundation met the construction documents and specifications submitted to Mathews County.

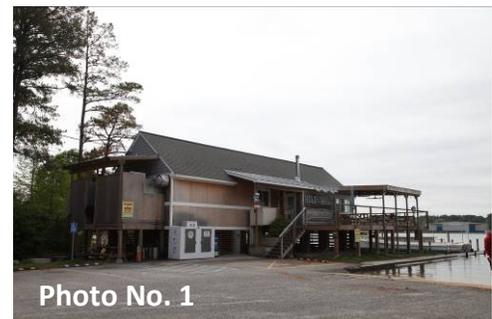
The commercial structure is a one (1) story timber framed restaurant structure with attached elevated decks utilized for outdoor dining, kitchen equipment, storage, and HVAC equipment. The roof of the restaurant structure consists of a gable A-framed roof surfaced with composite asphalt shingles. The roof over the outdoor dining area and kitchen equipment is a low sloped roof, also surfaced with composite asphalt shingles. A front elevation view of the structure is shown in **Photo No. 1**.

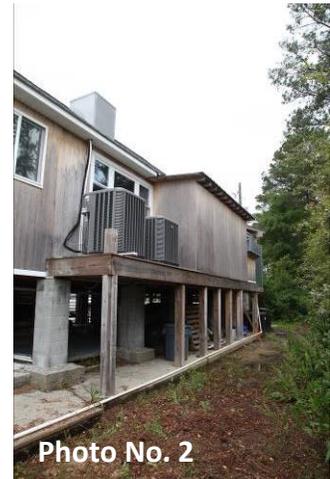
Photo No. 2

Our site visit observations revealed that additions had been constructed onto the existing restaurant and exterior deck, which were not shown on the construction documents provided by Bay Design. We noted that an open air and partially enclosed timber framed HVAC equipment/storage platform had been constructed along the rear elevation of the restaurant. Additionally, we noted that an enclosed and covered kitchen equipment/freezer timber framed addition had been added to the left elevation of the restaurant. Further, we noted that a single sloped timber framed roof had been installed over the front elevation exterior deck area. (See Photos No. 2, 3, and 4.)

- With the exception of the single sloped roof above the exterior deck, the kitchen equipment addition on the left elevation and the HVAC equipment platform and shed on the rear elevation were constructed without plans, specifications, and building permits.

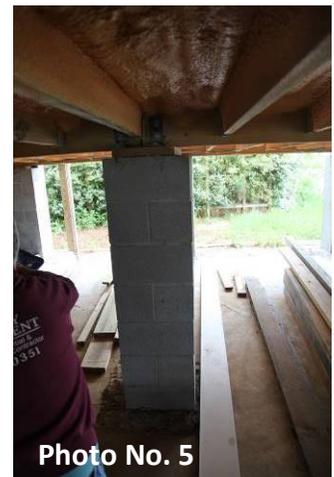
Photo No. 5

A review of the first floor framing below the restaurant structure revealed the floor joists to be 2 x 10 at 16" on center which spanned front to rear approximately 10'-6" between three (3) parallel multi-ply 2 x 12 girder lines. This framing layout matched the construction drawings provided by Bay Design. Further, these girders were supported by 16" x 16" grouted masonry piers spaced at approximately 7'-9" on center. The location of these CMU piers also matched the construction drawings provide by Bay Design. However, we noted that 5/8" on center lag bolts had been used in the hold-downs. (See Photo No. 5.)

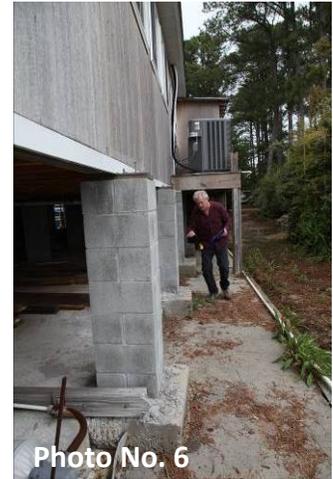
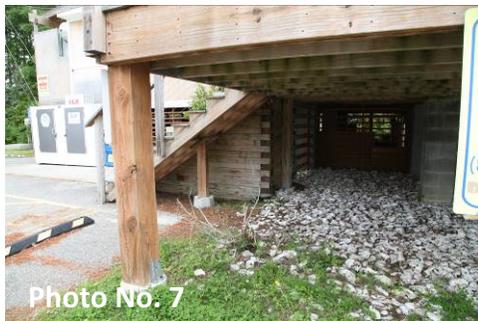
We also noted the specified Simpson HL53 hold-down angles had been installed to each side of the girders below the restaurant. However, we noted the installation of a single 2 x 8 treated plate rather than the specified double 2 x 8 plate on top of the CMU below these girders. Our review also revealed these 2 x 8 plates and Simpson angles were attached with two (2) 5/8" diameter anchor bolts. However, closer review revealed the outermost bolt to be a 5/8" diameter lag bolt that could be removed by hand. (See Photo No. 6.)

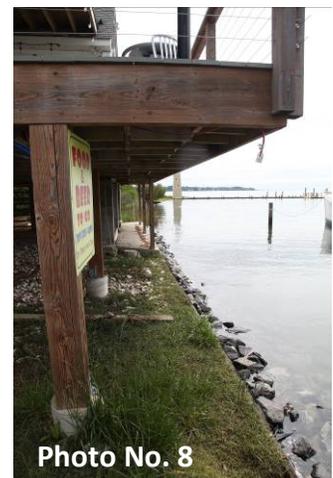
Our review of the timber framing of the exterior deck revealed it was not framed as per the construction documents. Rather, than installing three (3) ply 2 x 8 girders running left to right with 2 x 8 joists at 16" on center, front to rear, as shown on the construction documents, we noted that the framing consisted of two (2) ply 2 x 12's spanning, front to rear at each exterior 8" x 8" post line. Closer review revealed the two (2) ply 2 x 12's spanned 12'-0" from the exterior two (2) ply 2 x 12 band board to the masonry piers below the front elevation wall of the main entrance. We noted the exterior deck floor joists were 2 x 12's at 16" on center spanning approximately 7'-9" left to right. Closer review revealed the absence of an intermediate pier and girder line, as shown on the construction documents provided by Bay Design. (See Photo No. 7)

- The as-built timber framing of the exterior elevated deck does not match the construction documents prepared by Bay Design.
- The two (2) ply 2 x 12 flush girders spanning 12'-0" are not structurally adequate to support the required 100 psf live load. The stringers steel cable horizontal railing will not maintain the required maximum 4" spacing when pushed upon.
- The 1,500 psf actual bearing pressure of the soil below the footings is below the minimum allowable soil bearing pressure that the footings were designed for.

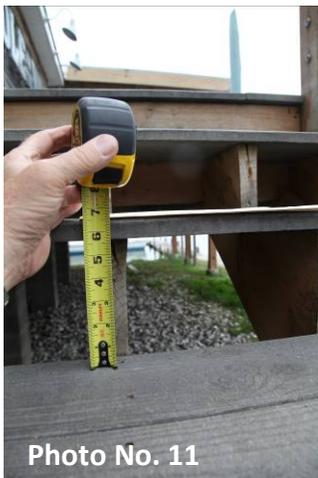
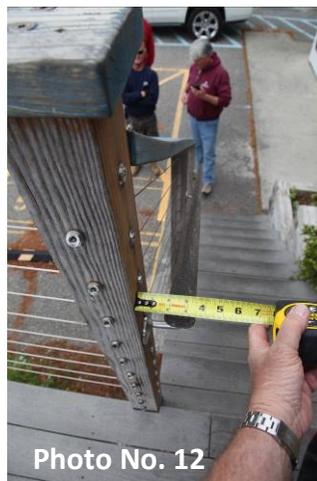
Our review of the entrance stairs revealed the stairs were constructed with four (4) 2 x 12 stringers and open risers. **(See Photo No. 10.)** We noted the stringers were split at each of the tread fasteners. The height of the risers varied from the first riser height of 7 1/4" at the bottom with the remaining riser heights ranging from 6 5/8" to 6 7/8". **(See Photo No. 11.)** We noted the stairway was approximately 36" in width with a single guardrail assembly and handrail on the right side. Closer review revealed the handrail did not extend beyond the bottom or top riser. **(See Photo No. 12.)**

Once these foundation issues are designed and corrected, we recommend that a redesign of the entrance stairway be provided. At that time, an approximately designed and constructed guardrail assembly can also be constructed.

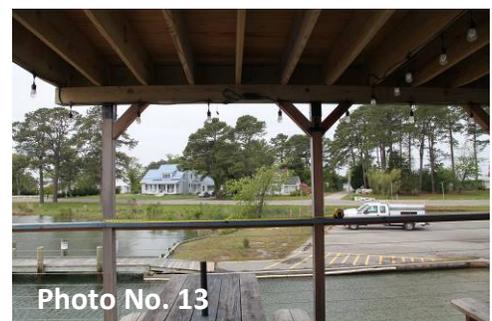
Further review revealed the top rail of the deck and stair were constructed with flat 2 x 6 with the intermediate railing consisting of horizontal stainless steel cables. While the cables were spaced at 4" on center, with a span of 6'-1" the cables could easily be pushed by hand to create a space greater than 4". **(See Photo No. 13)**
